# Manhole Inspection Summary

Manhole # S45C2\_034MH

Insp Date: **12/28/07 8:52 AM**

**Location** Address: **3800 Pennington Ave**

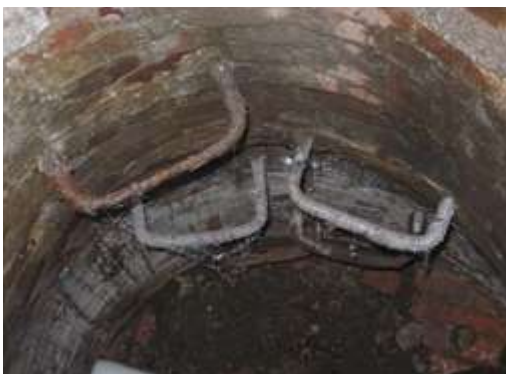
Steps

Count: **5** Missing: **0** ☒ **Corroded**

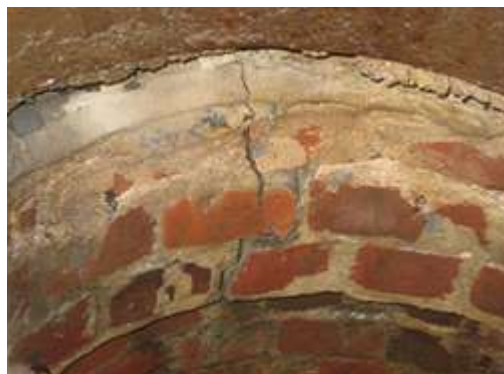
Defect 1

Condition: ☐ Sound ☒ **Cracked** ☐ Root Intrusion ☐ Loose Brick ☐ Deteriorated

Infiltration: ☐ None ☐ Joint ☐ Cracks ☒ **Mortar** ☐ Roots ☐ Wall

Cracked chimney

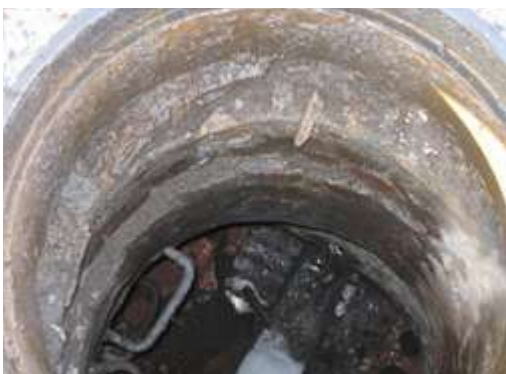
Defect 2

Offset: **2.5** (in.)

Frame offset

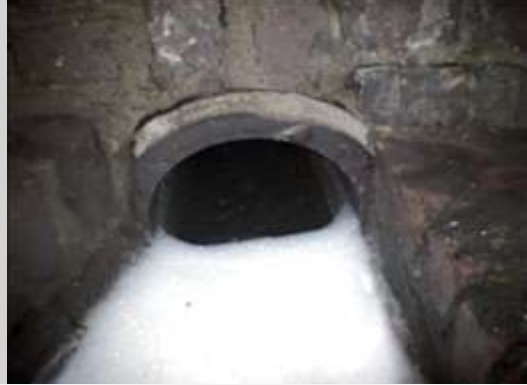
12 O'Clock Outflow

Pipe Height: **8.4** (in.) Rod and Bar (Angled)  
Pipe Material: **Clay** ☐ Pipe Lined  
Invert Depth: **10.07** (ft.) Flow Characteristics: **Slow**  
Deposits: ☒ None ☐ Mud ☐ Sludge ☐ Debris ☐ Grease  
Silt Depth: (in.) Deposits Extent:  
Infiltration: **None** Pipe Seal Cond: **Sound**

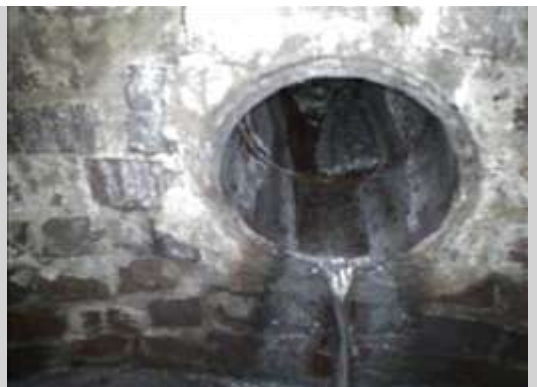
6 O'Clock Inflow

Pipe Height: **8.4** (in.) Rod and Bar (Angled)  
Pipe Material: **DIP/CI** ☐ Pipe Lined  
Invert Depth: **8.29** (ft.) Flow Characteristics: **Fast**  
Deposits: ☒ None ☐ Mud ☐ Sludge ☐ Debris ☐ Grease  
Silt Depth: (in.) Deposits Extent:  
Infiltration: **None** Pipe Seal Cond: **Sound**

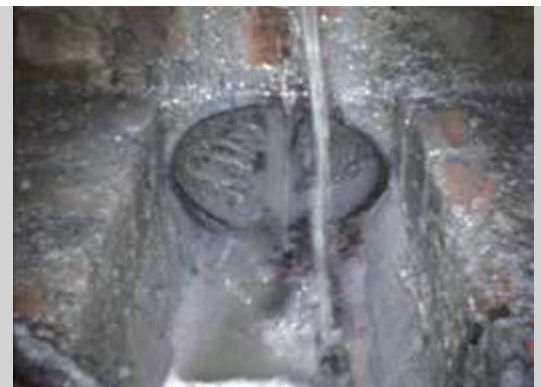
Drop In @ 6 O'Clock

Drop: **Outside** Rod and Bar  
Angled: **Yes** Reading: **8.83** (ft.)  
Inv Depth: **9.83** (ft.)  
Drop Condition: **Open**

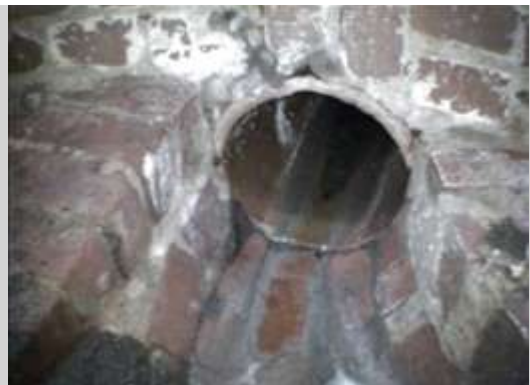
9 O'Clock Inflow

Pipe Height: **9.6** (in.) Rod and Bar (Angled)

Infiltration: **None** Pipe Seal Cond: **Sound**
